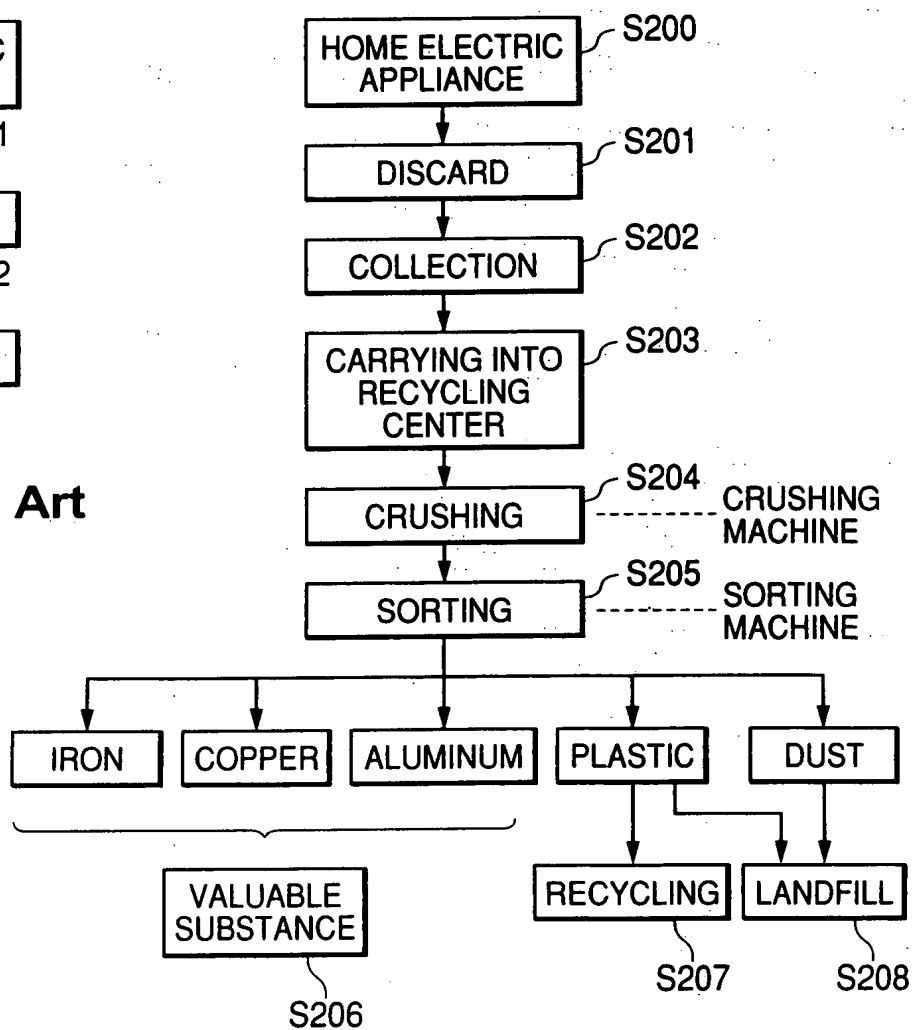
FIG. 23(b)

CASE OF PASSING DISPOSAL FACILITIES

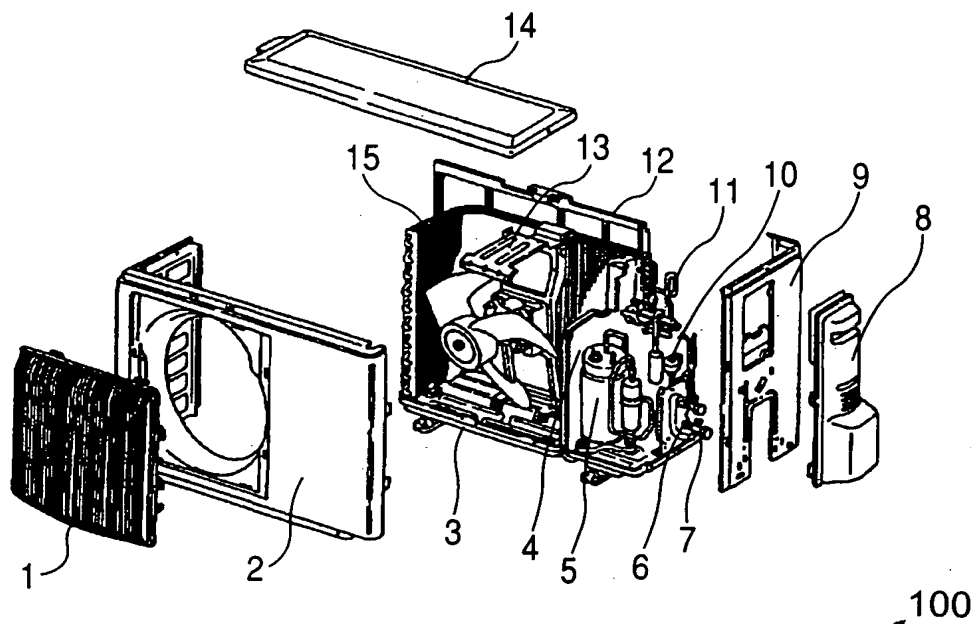
FIG. 14

REFERENCE NUMBER TO EXPLODED VIEW	COMPONENT NAME	MATERIAL	RECYCLING CODE	DIFFICULT- TO-CRUSH SUBSTANCE CODE
1	FAN COVER	POLYPROPYLENE	♻️	
2	FRONT COVER	IRON	♻️	
3	BASE	IRON	♻️	
4	SEPARATOR	IRON	♻️	
5	COMPRESSOR	IRON + COPPER + MAGNETIC SUBSTANCE	♻️	×
6	STOP VALVE	COPPER ALLOY	♻️	
7	STOP VALVE	COPPER ALLOY	♻️	
8	SERVICE PANEL	POLYPROPYLENE	♻️	
9	BACK PANEL	IRON	♻️	
10	PIPE ASSEMBLY	COPPER	♻️	
11	FOUR-WAY VALVE	COPPER ALLOY+IRON	♻️	
12	CONDENSER NET	POLYPROPYLENE	♻️	
13	MOTOR SUPPORT	IRON	♻️	
14	TOP PANEL	IRON	♻️	
15	HEAT EXCHANGER	ALUMINUM + COPPER	♻️
